# AWA Newsletter

#64

April 2011

## RESTORING A 1937 UTAH JR

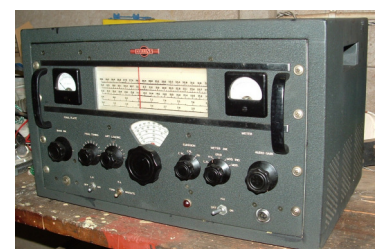
Collins 32V3

There are always those with slightly more power, as in any gathering of Hams, but they are certainly not in the majority. The Collins 32V-3, pictured, runs at 80w carrier with ease and was specifically built as an AM transmitter in the 50's. There are some AM

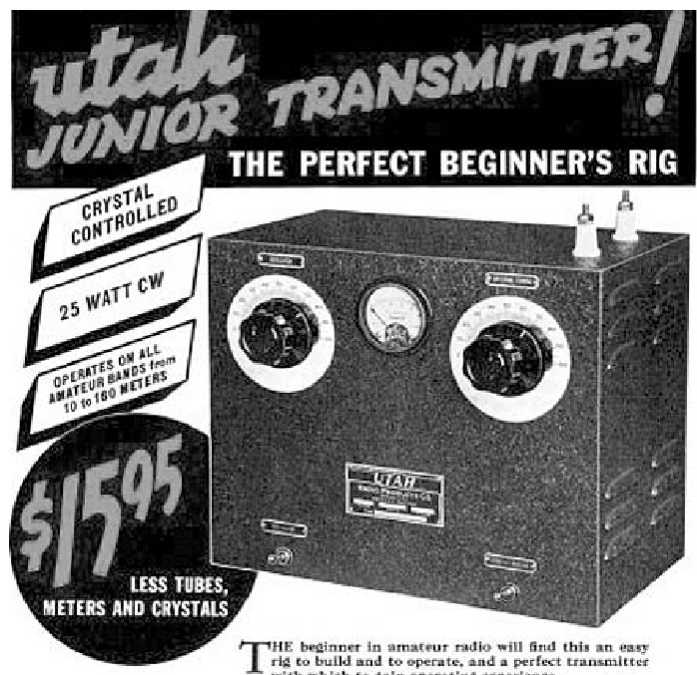
Overall, I found my unit to be in good condition for a transmitter now approaching its 75th anniversary. The exterior black wrinkle finish on the cabinet was in very good condition, needing only a thorough cleaning. I find that a lanolin based hand cleaner, like D&L or GoJoe, works very nicely in cleaning the

Although the cabinet was in good order, the chassis of the RF and power supply decks were another matter. Both were showing signs of rust forming under the paint, and in several spots moderate rust pitting of the metal was observed. I therefore planned to strip down and refinish both of the sheet metal chassis with a powder coating process.

I disassembled and removed the components (except the air variables) from the RF deck, inventorying all into Ziploc bags to ease the future rebuild. I then ran both the RF and power supply decks through my dishwasher, placing them on the upper rack to avoid heat damage.

This treatment really does wonders and no damage occurs if the system is run at low temperature. The units emerged looking like new, and I took a few moments to clean and tighten all hardware as well as to lubricate the shafts on the air variable caps.

With the chassis now stripped, I sent both off to the powder coater with instructions to remove the old paint and refinish in a low gloss black to match the original color. After a week at the shop, both chassis were returned to me looking like new, the rust was gone and the finish looked very much like a vintage paint product.

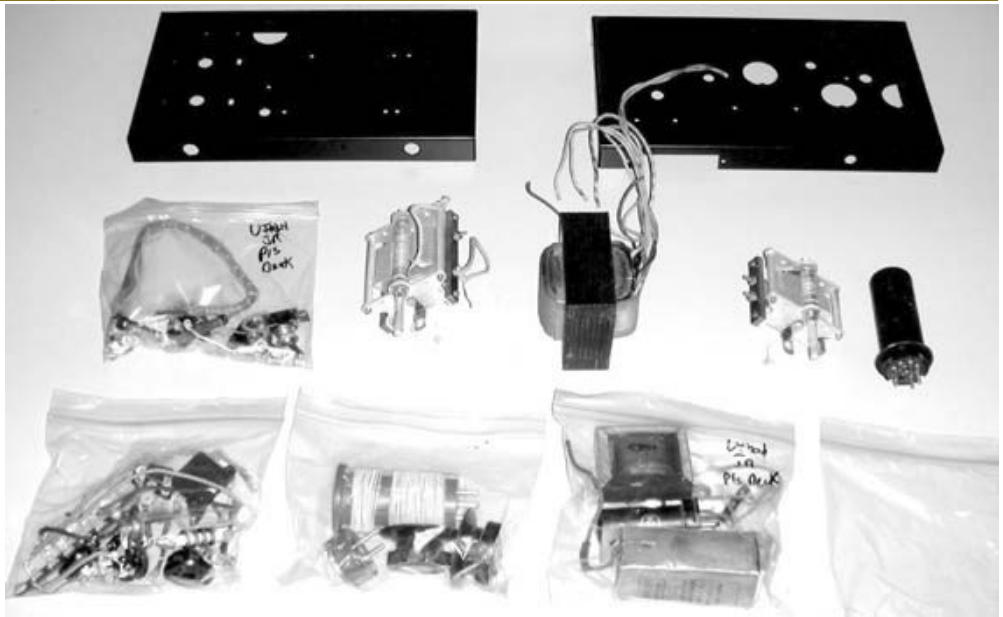
Power Supply and RF deck after disassembly

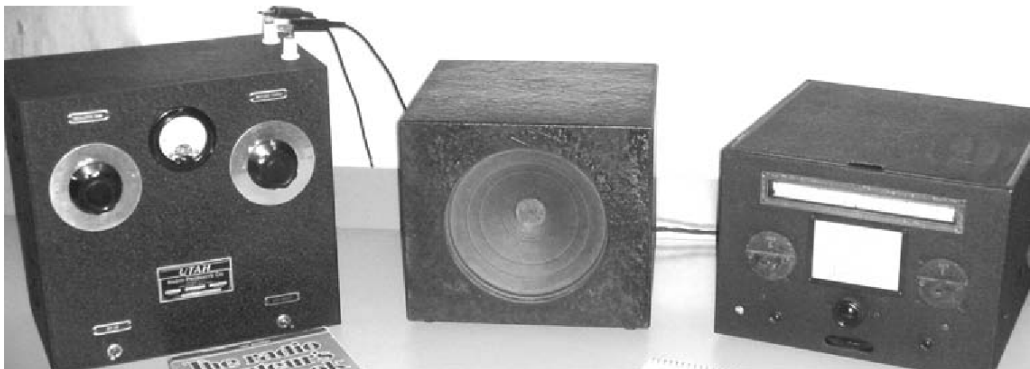
Author's National FB7/Utah Jr. station. Key and receiver power supply not transmit/receive shown.
