Newsletter  
The Antique Wireless Association of Southern Africa  
18th Anniversary

# Hallicrafters Model SX-28 Communications Receiver (1941)

(Part III)

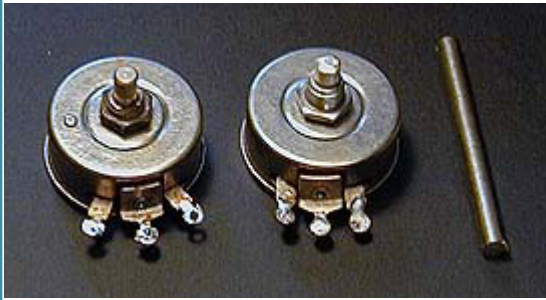
The votes were unanimous, so I pulled the S-meter adjustment potentiometer and quickly found that its center terminal was leaking to the case. Not a dead short, but certainly sufficient to leak enough voltage to prevent the plate of V7 from receiving its share. I temporarily connected a replacement potentiometer and was thrilled to see the S-meter come back to life. Problem solved!

That weekend happened to be the occasion of the [NWVRS](#) swap meet in Portland. I found a number of useful parts at that meet, including a good potentiometer to replace the bad old one. The new pot's shaft was longer than needed, but a few strokes of the hacksaw cured that. After rounding off the end a bit, you could hardly tell the new unit from the old. The next photo shows old and new pots together.

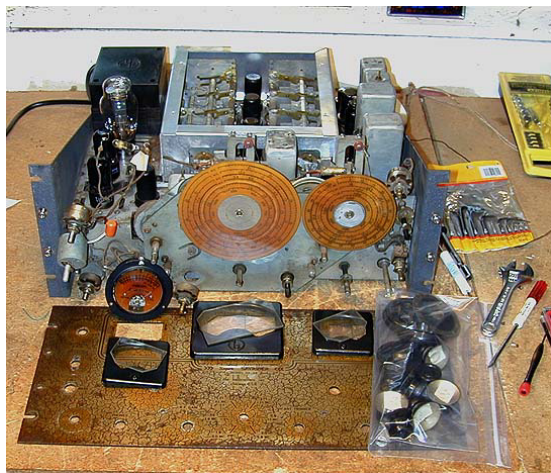
The next photo shows the front panel removed from the receiver. This involves removing all the knobs, unscrewing the mounting nuts from the phone jack and toggle switches, disconnecting and removing the S-meter, and carefully taking off the dial covers and their glasses. To prevent loss, most of the mounting nuts and assorted screws have been reattached to the places they came from. The knobs are carefully squirreled away in a big Ziploc bag for later

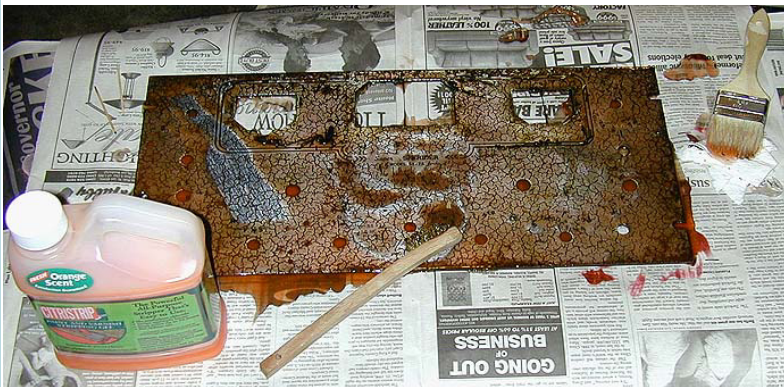
The next step was to strip the old dark gunk from the panel. When I removed the dial covers, the gunk underneath looked suspiciously orange, almost like old shellac. I ran a sink full of hot soapy water and let the panel soak for a while, then started gently scrubbing. Sure enough, the finish was shellac, and it came off easily.

Lots of old paint remained in the stamped lettering and wrinkle texture, however. After drying the panel, I lay it down on a thick pad of newspapers and applied a thick coating of Citri-Strip stripper. A couple of hours later, the paint had loosened sufficiently to come off easily with a

Here is our patient at this stage of the proceedings. Looks messy, but things will get better soon!

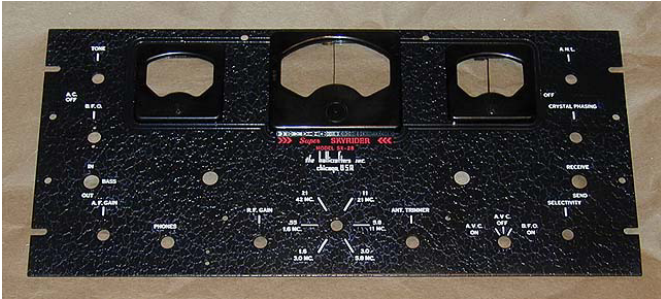
The next day I gently polished away the haze, using Novus Plastic Polish #2 (my favorite all-purpose polish). The Novus removed the haze and gave a little extra protection to the entire panel. The next photo shows the restored panel with the dial covers back in place.
